ASBESTOS SURVEY REPORT

(REFURBISHMENT/ DEMOLITION)

**Property Name: Horgans Quay Site,
Cork**

Report No. PE17-587

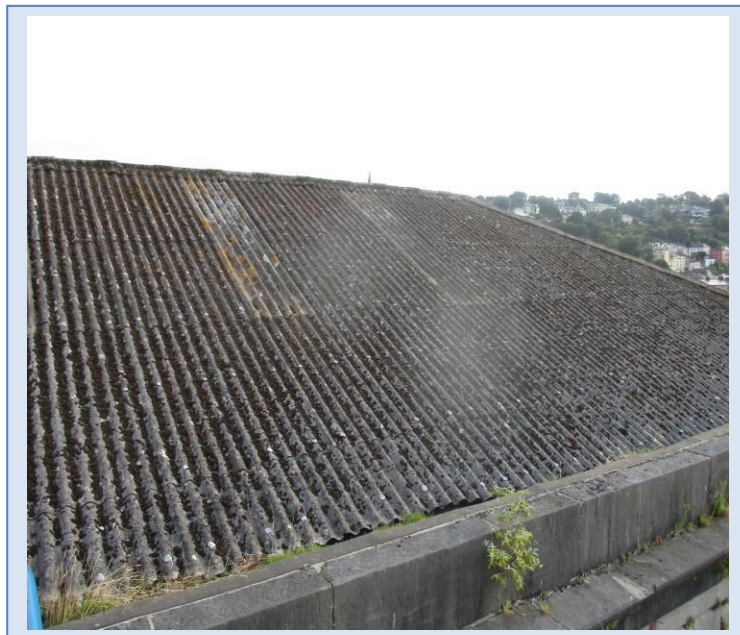
MATERIAL ASSESSMENT		PRIORITY ASSESSMENT
Product type	Cement sheeting	Normal occupant activity	N/A
Extent of damage	High	Likelihood of disturbance	N/A
Surface treatment	Unsealed	Human exposure potential	N/A
Asbestos type	Amosite, Crocidolite & Chrysotile	Maintenance activity	N/A
	Material assessment score N/A	TOTAL SCORE: N/A	Material assessment score N/A

The cement sheeting, cement gutter & downpipes identified on the roof of Building 1 contains Amosite (Brown), Crocidolite (blue) and Chrysotile (white) asbestos fibres. Asbestos cement products generally contain between 10 to 15 % asbestos fibres bound in Portland cement

The asbestos cement sheeting, gutters & downpipes should be removed by an asbestos removal contractor and disposed of as asbestos waste before the demolition works commence

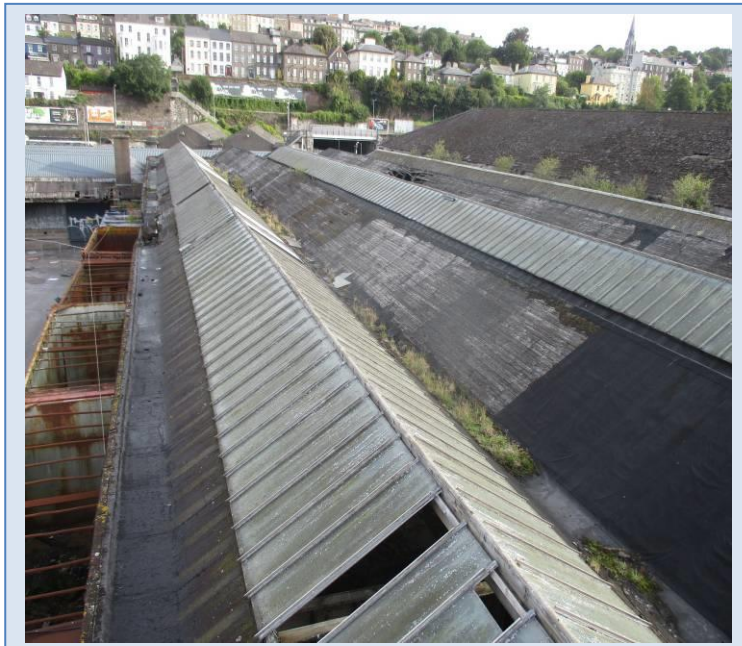
MATERIAL ASSESSMENT		PRIORITY ASSESSMENT
Product type	Rope	Normal occupant activity	N/A
Extent of damage	High	Likelihood of disturbance	N/A
Surface treatment	Unsealed	Human exposure potential	N/A
Asbestos type	Chrysotile	Maintenance activity	N/A
	Material assessment score N/A	TOTAL SCORE: N/A	Material assessment score N/A

The rope seals found behind the glazing bars of the roof lights on Building 1 contain Chrysotile (white) asbestos fibres. Asbestos containing rope seals can contain up to 100% asbestos fibres, usually Chrysotile

The asbestos containing rope seals should be removed by an asbestos removal contractor and disposed of as asbestos waste before the demolition works commence

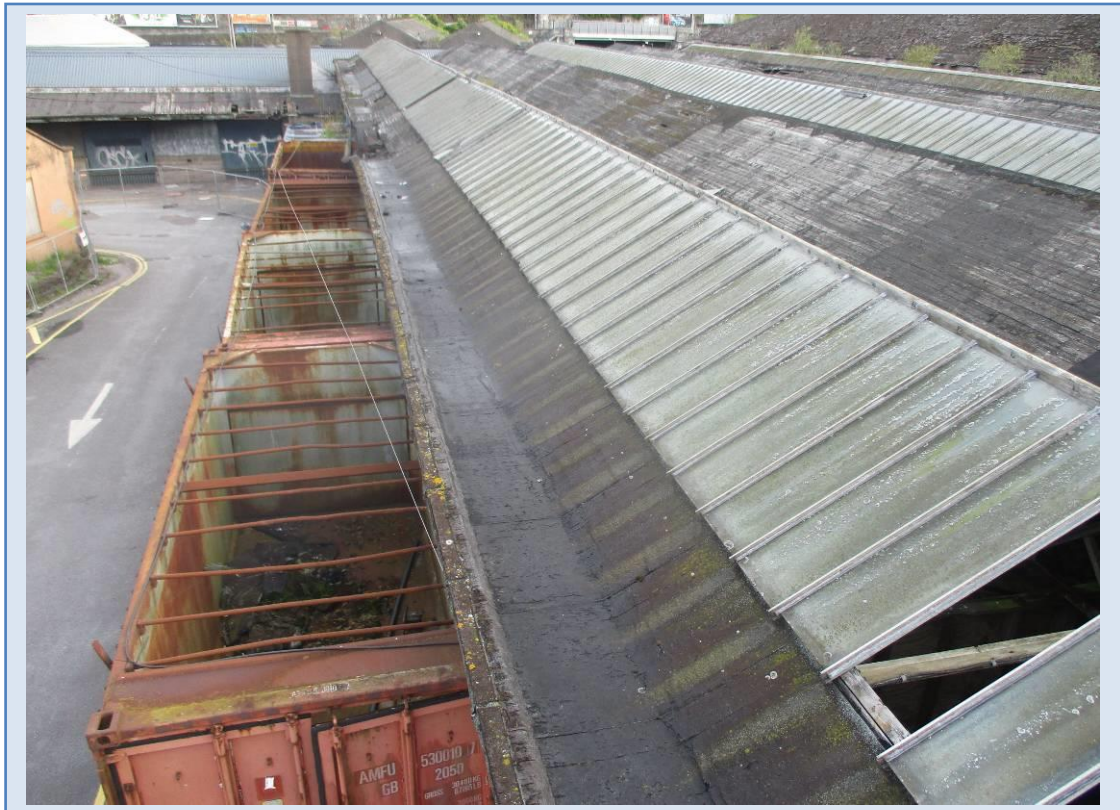
Asbestos containing rope seals behind the glazing bars of the roof lights on Building 1

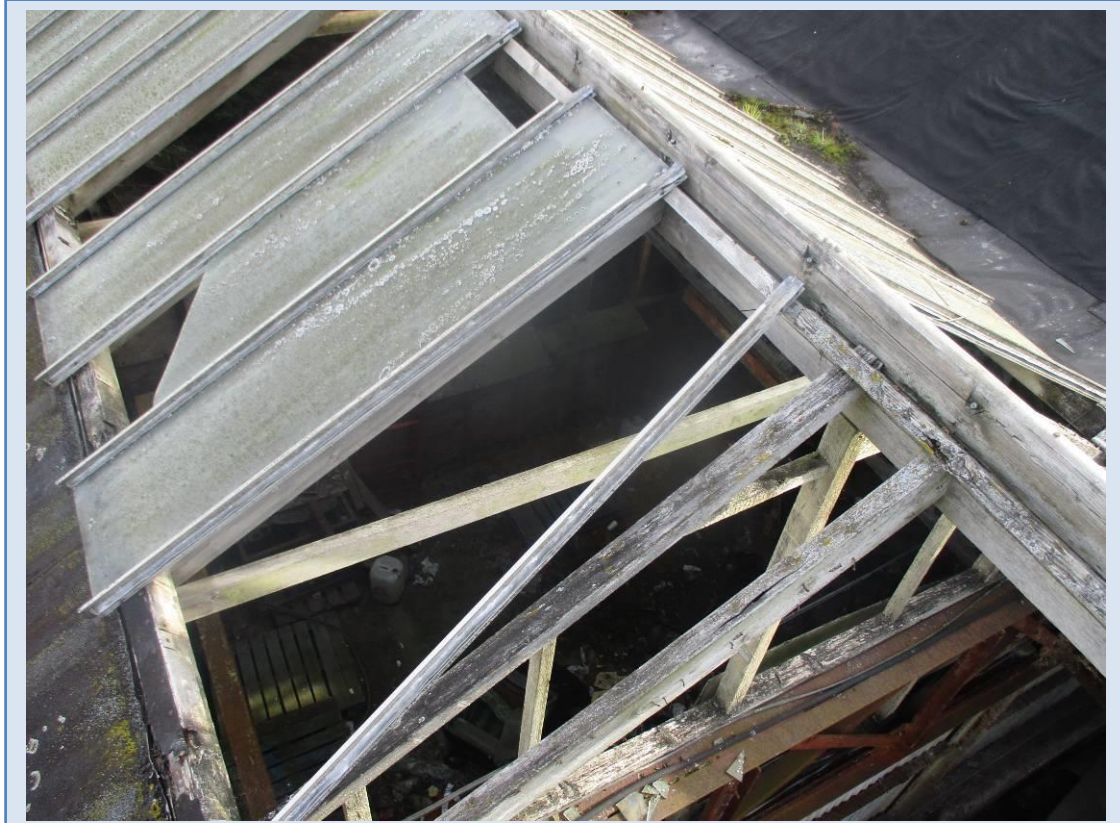
Asbestos containing rope seals debris internally in Building 1

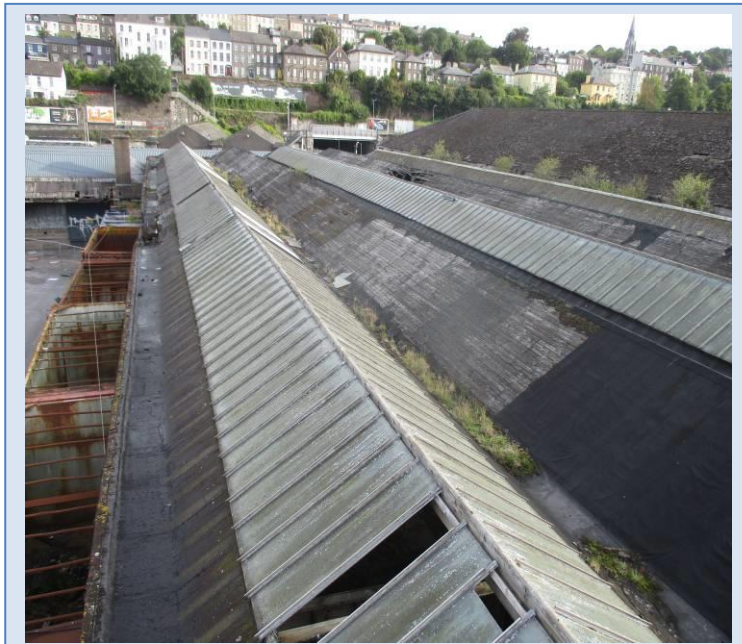
MATERIAL ASSESSMENT		PRIORITY ASSESSMENT
Product type	Felt	Normal occupant activity	N/A
Extent of damage	Medium	Likelihood of disturbance	N/A
Surface treatment	Composite material	Human exposure potential	N/A
Asbestos type	Chrysotile	Maintenance activity	N/A
	Material assessment score N/A	TOTAL SCORE: N/A	Material assessment score N/A

The felt identified on the section of the roof area with the roof lights on Building 1 contains Chrysotile (white) asbestos fibres. Asbestos containing felt contains small quantities of asbestos fibres bound in a matrix

The asbestos containing felt should be removed by an asbestos removal contractor and disposed of as asbestos waste before the demolition works commence

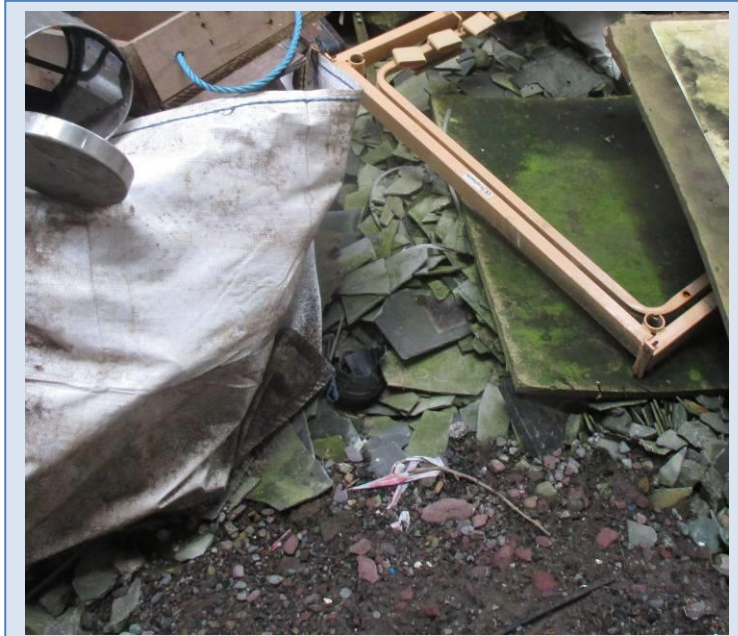
MATERIAL ASSESSMENT		PRIORITY ASSESSMENT
Product type	Cement debris	Normal occupant activity	N/A
Extent of damage	High	Likelihood of disturbance	N/A
Surface treatment	Unsealed	Human exposure potential	N/A
Asbestos type	Amosite, Crocidolite & Chrysotile	Maintenance activity	N/A
	Material assessment score N/A	TOTAL SCORE: N/A	Material assessment score N/A

The cement debris found throughout building 1 contains Amosite (Brown), Crocidolite (blue) and Chrysotile (white) asbestos fibres. Asbestos cement products generally contain between 10 to 15 % asbestos fibres bound in Portland cement

The asbestos cement debris should be removed by an asbestos removal contractor and disposed of as asbestos waste before the demolition works commence

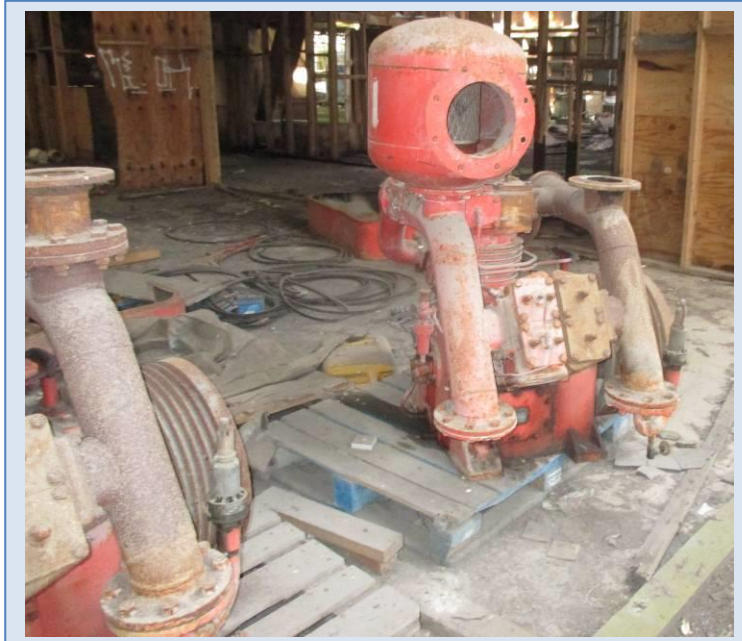
MATERIAL ASSESSMENT		PRIORITY ASSESSMENT
Product type	CAF gasket	Normal occupant activity	N/A
Extent of damage	High	Likelihood of disturbance	N/A
Surface treatment	Unsealed	Human exposure potential	N/A
Asbestos type	Chrysotile	Maintenance activity	N/A
	Material assessment score N/A	TOTAL SCORE: N/A	Material assessment score N/A

The CAF (compressed asbestos fibre) gaskets found between the flanges of the plant and equipment in the entrance to the east side of Building 1 contain Chrysotile (white) asbestos fibres. The gaskets are comprised almost exclusively of Chrysotile asbestos, with a small amount of binder

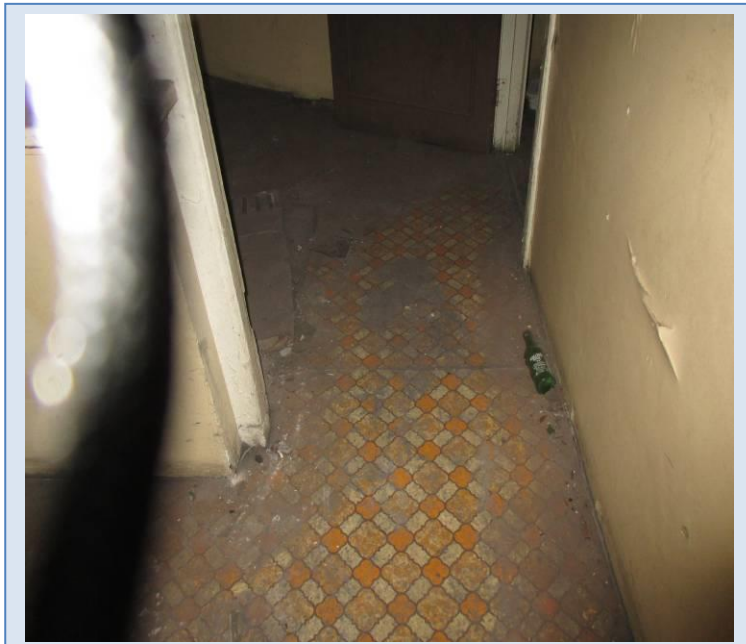
MATERIAL ASSESSMENT		PRIORITY ASSESSMENT
Product type	Paper	Normal occupant activity	N/A
Extent of damage	Medium	Likelihood of disturbance	N/A
Surface treatment	Unsealed	Human exposure potential	N/A
Asbestos type	Chrysotile	Maintenance activity	N/A
	Material assessment score N/A	TOTAL SCORE: N/A	Material assessment score N/A

The paper backed linoleum found in the shed to house section of building 1 contains Chrysotile (white) asbestos fibres. Asbestos paper contains up to 100% asbestos fibres

The asbestos paper backed linoleum should be removed by a specialist asbestos removal contractor under controlled conditions and disposed of as asbestos waste before the demolition works commence

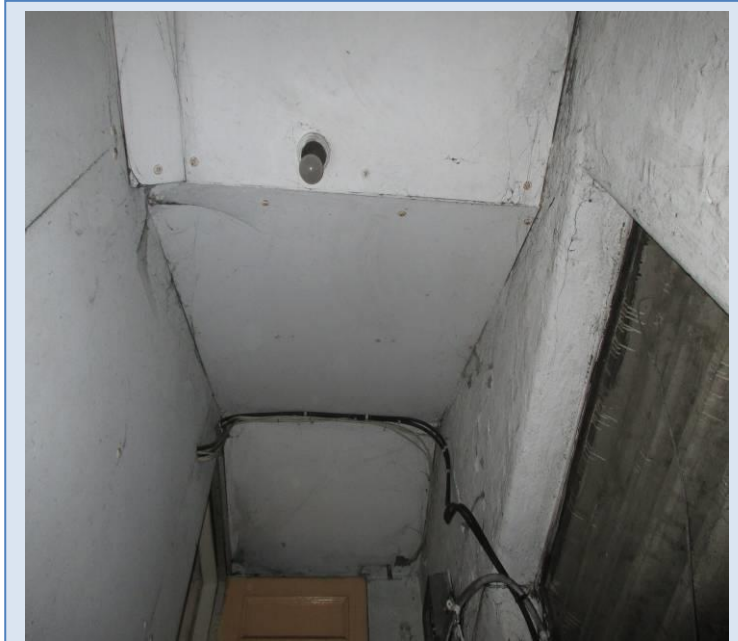
MATERIAL ASSESSMENT		PRIORITY ASSESSMENT
Product type	Insulation board	Normal occupant activity	N/A
Extent of damage	Medium	Likelihood of disturbance	N/A
Surface treatment	Painted	Human exposure potential	N/A
Asbestos type	Amosite & Chrysotile	Maintenance activity	N/A
	Material assessment score N/A	TOTAL SCORE: N/A	Material assessment score N/A

The asbestos insulation board (AIB) found on the walls and the ceilings of the stairs to the basement in Building 4 contain Amosite (Brown) and Chrysotile (white) asbestos fibres. Asbestos insulation boards can contain between 25-50% asbestos fibres

The asbestos insulation boards should be removed by a specialist asbestos removal contractor under controlled conditions and disposed of as asbestos waste before the demolition works commence

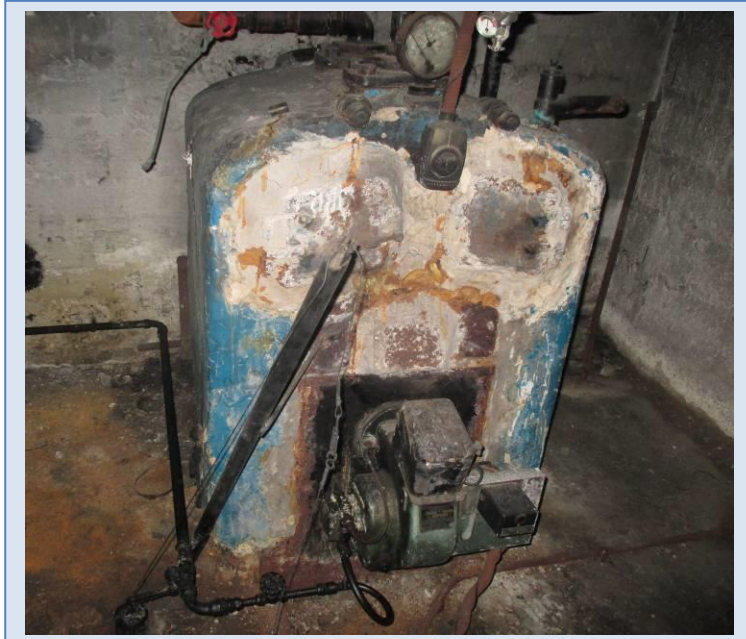
MATERIAL ASSESSMENT		PRIORITY ASSESSMENT
Product type	Thermal insulation	Normal occupant activity	N/A
Extent of damage	High	Likelihood of disturbance	N/A
Surface treatment	Unsealed	Human exposure potential	N/A
Asbestos type	Amosite & Chrysotile	Maintenance activity	N/A
	Material assessment score N/A	TOTAL SCORE: N/A	Material assessment score N/A

The asbestos containing thermal insulation should be removed by a specialist asbestos removal contractor under controlled conditions and disposed of as asbestos waste before the demolition works commence

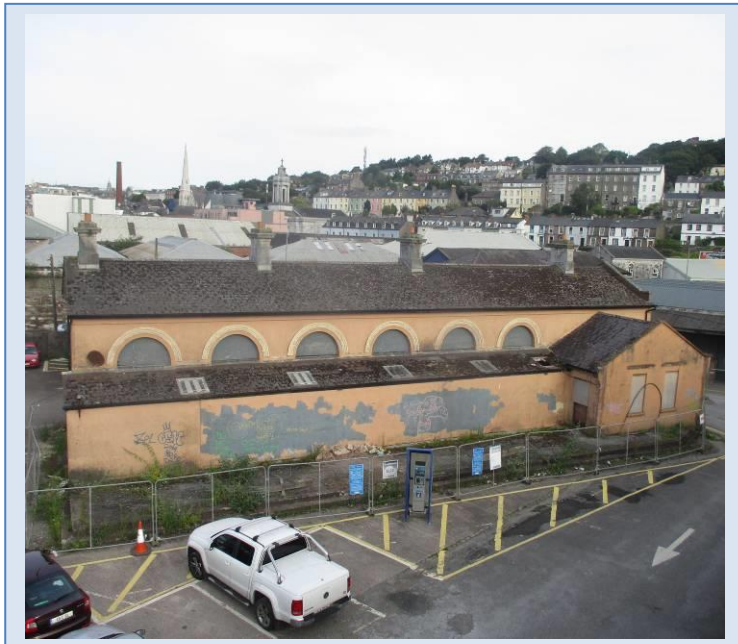
MATERIAL ASSESSMENT		PRIORITY ASSESSMENT
Product type	Cement slates	Normal occupant activity	N/A
Extent of damage	Medium	Likelihood of disturbance	N/A
Surface treatment	Unsealed	Human exposure potential	N/A
Asbestos type	Chrysotile	Maintenance activity	N/A
	Material assessment score N/A	TOTAL SCORE: N/A	Material assessment score N/A

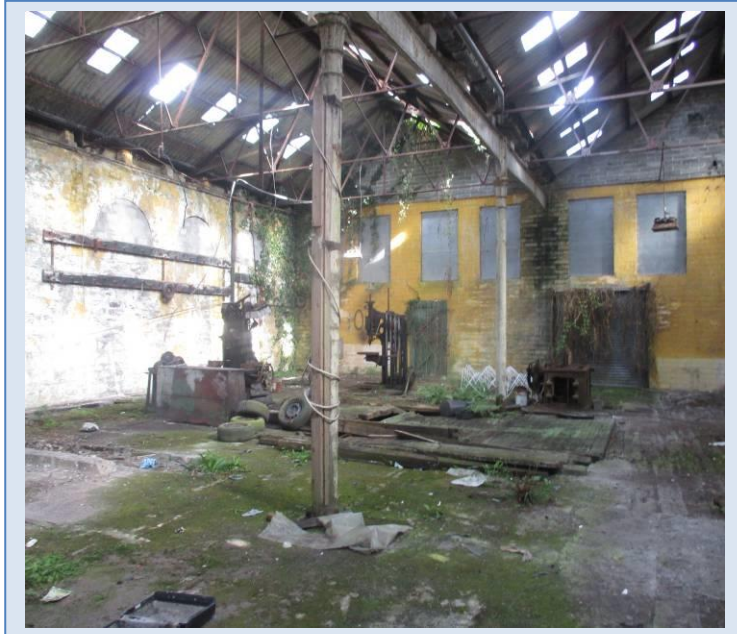
MATERIAL ASSESSMENT		PRIORITY ASSESSMENT
Product type	Cement sheeting, gutters	Normal occupant activity	N/A
Extent of damage	Medium	Likelihood of disturbance	N/A
Surface treatment	Unsealed	Human exposure potential	N/A
Asbestos type	Chrysotile	Maintenance activity	N/A
	Material assessment score N/A	TOTAL SCORE: N/A	Material assessment score N/A

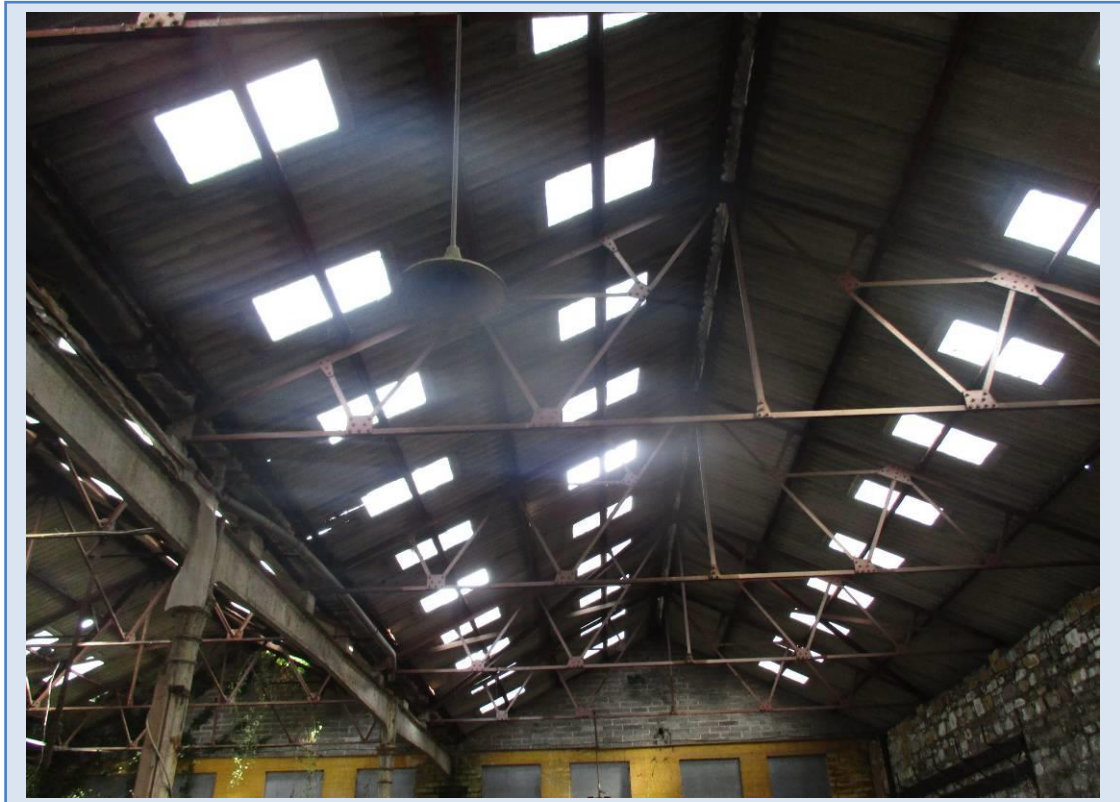
Asbestos cement roof sheeting in Building 7

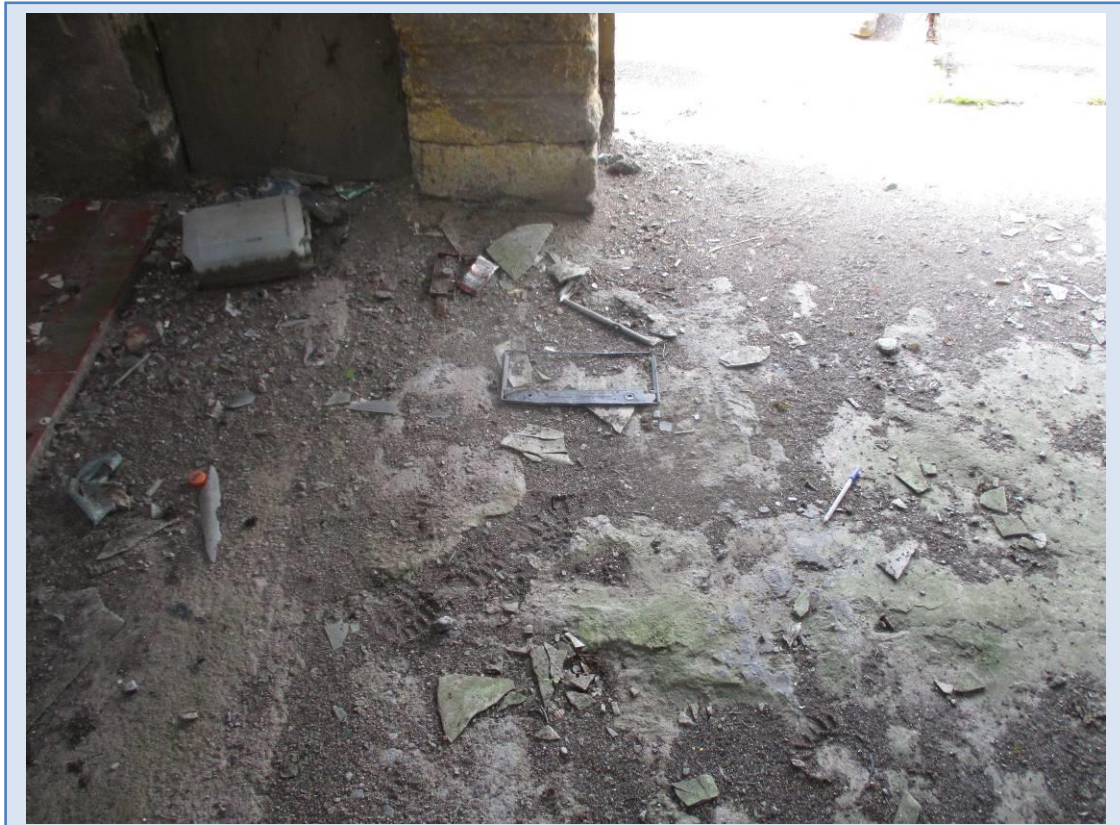
Asbestos cement sheeting debris in Building 7

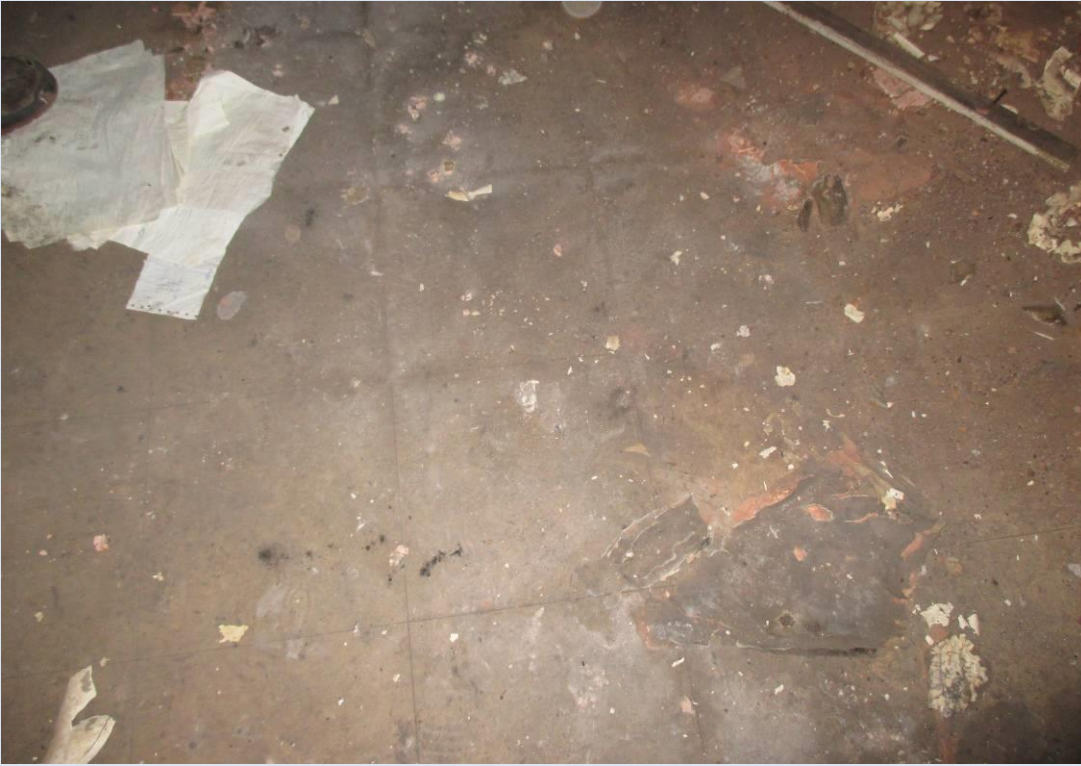
Floor tiles in building 1. No ACM's (asbestos containing materials) detected

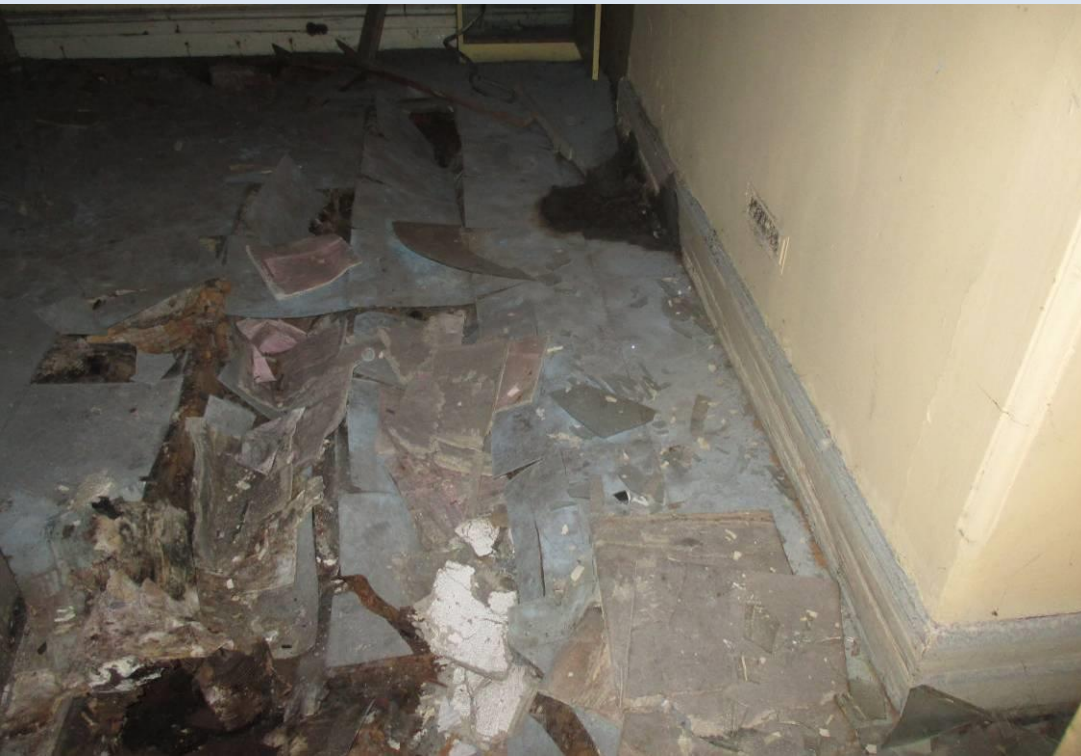
Floor tiles in building 1. No ACM's detected

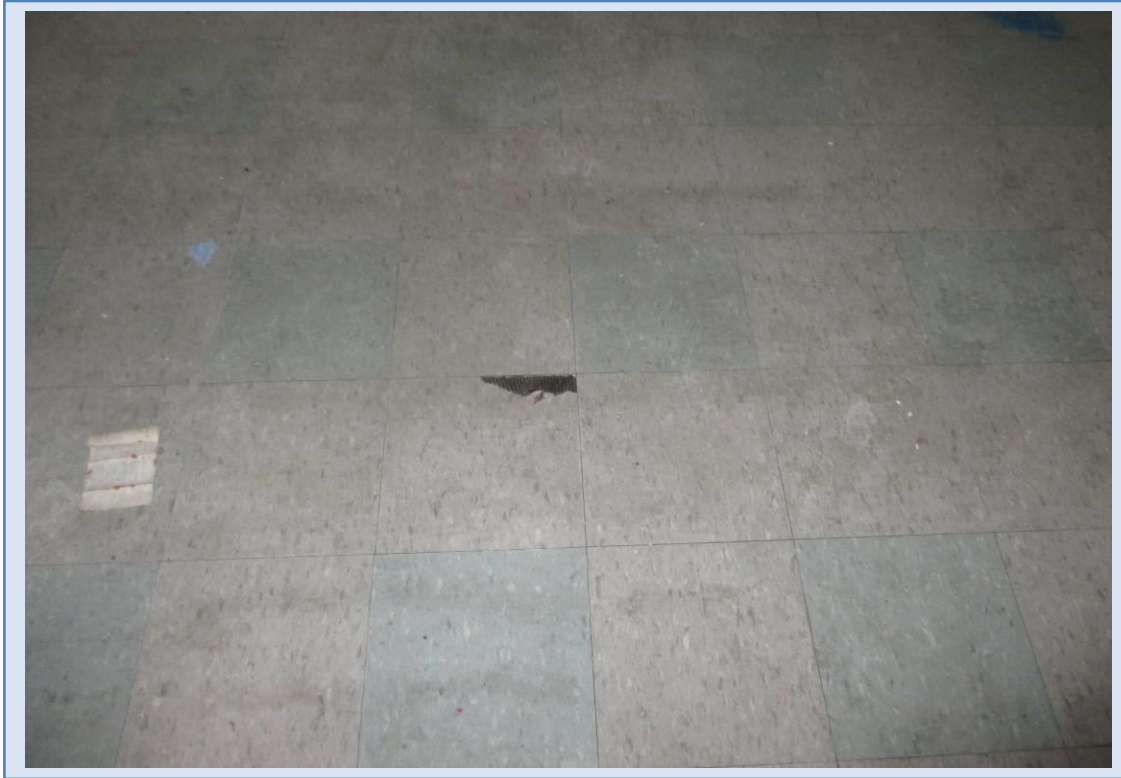
Floor tiles in building 5. No ACM's detected

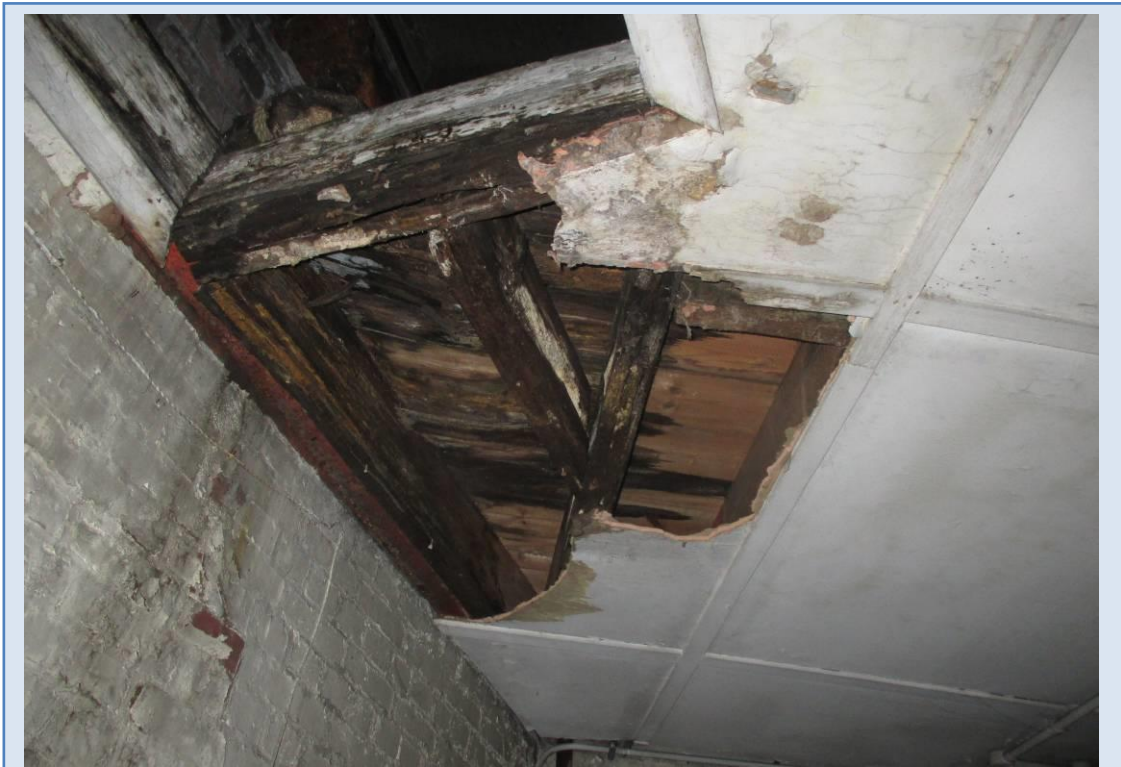
Ceiling boards in building 4. No ACM's detected

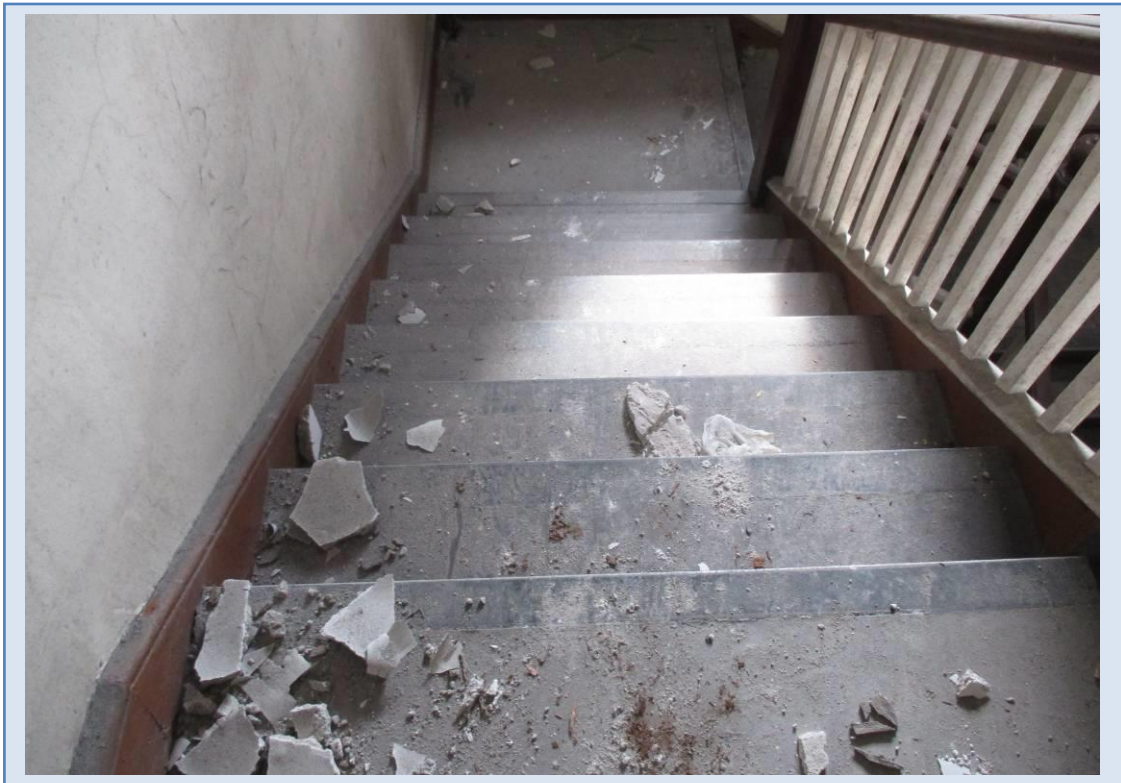
Stair nosing in building 4. No ACM's detected

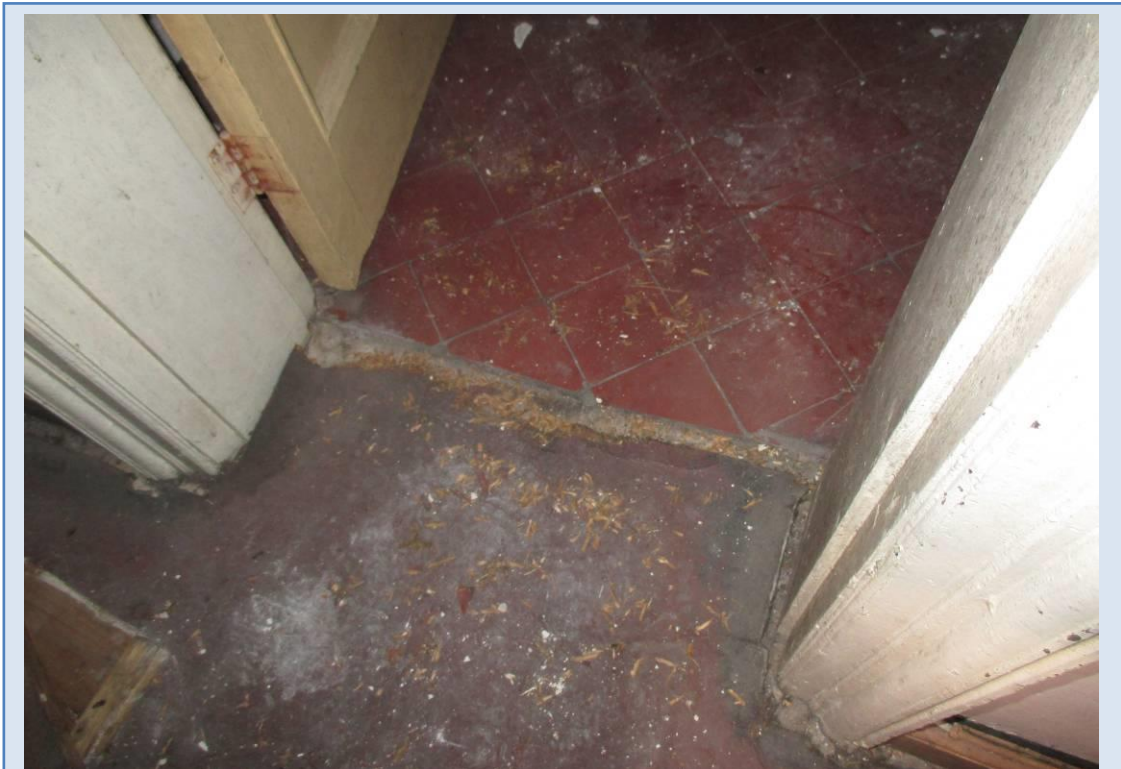
Floor covering in building 4. No ACM's detected

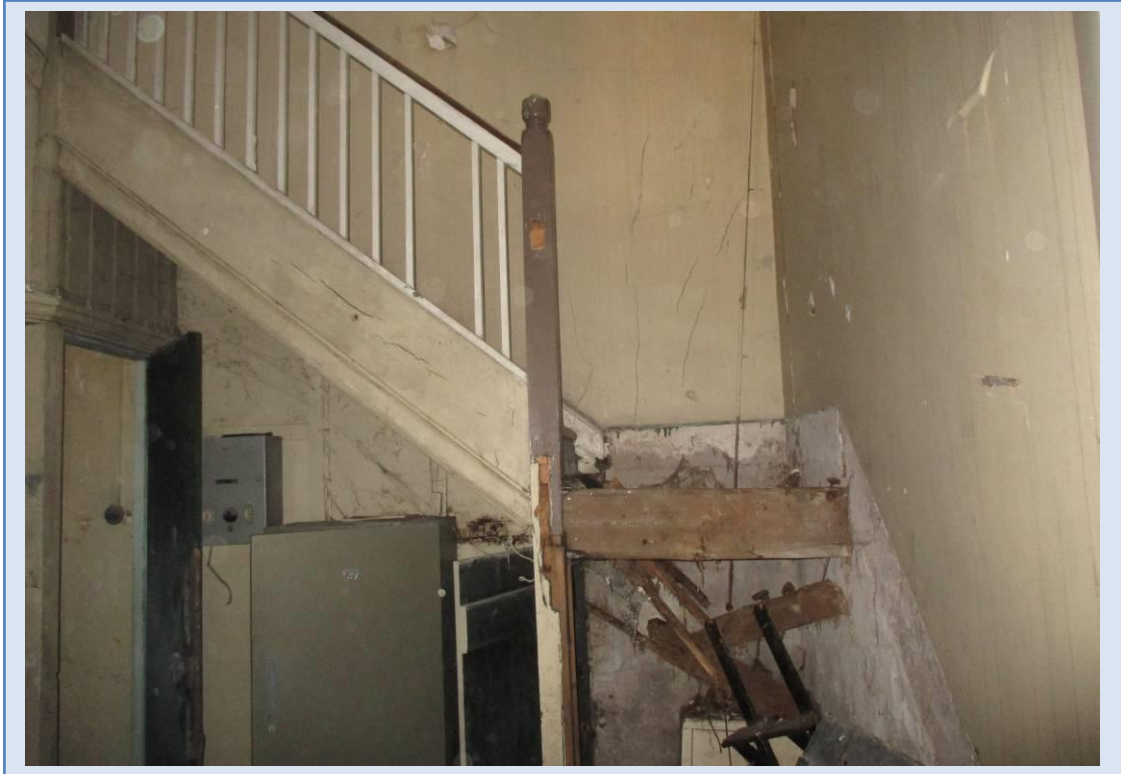
1st floor of the rear house in building 1 was not accessible

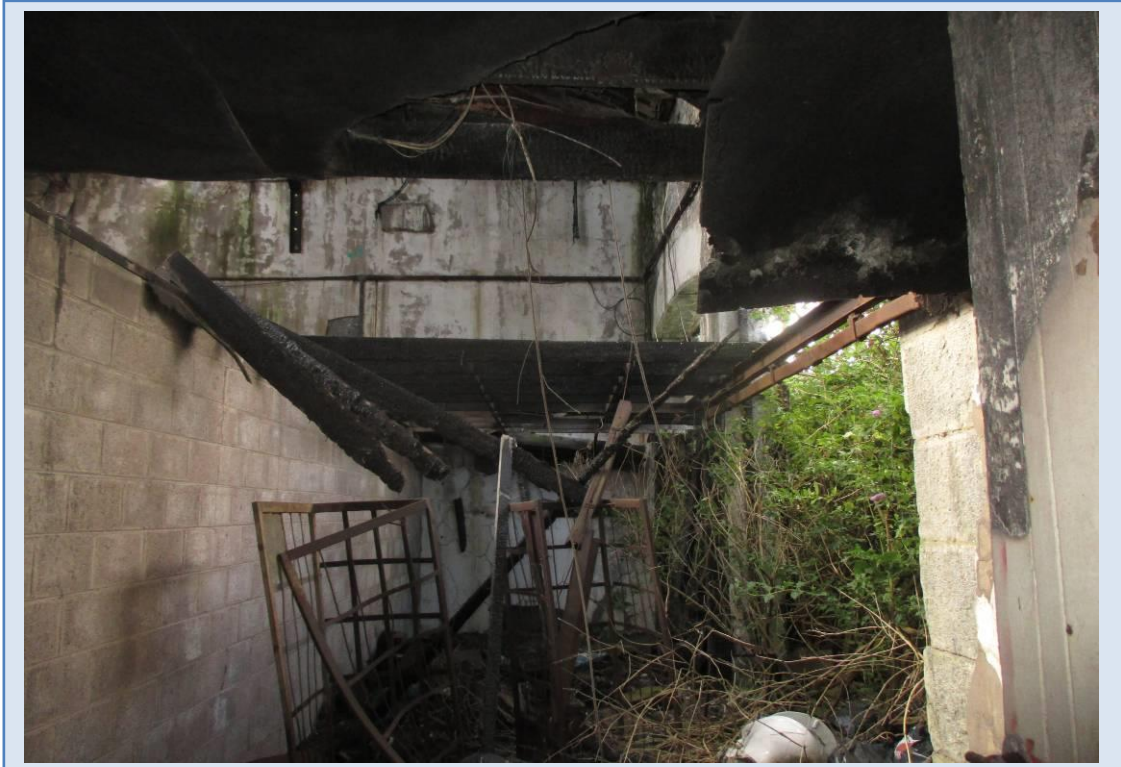
The house to the west side of building 1 was not accessible

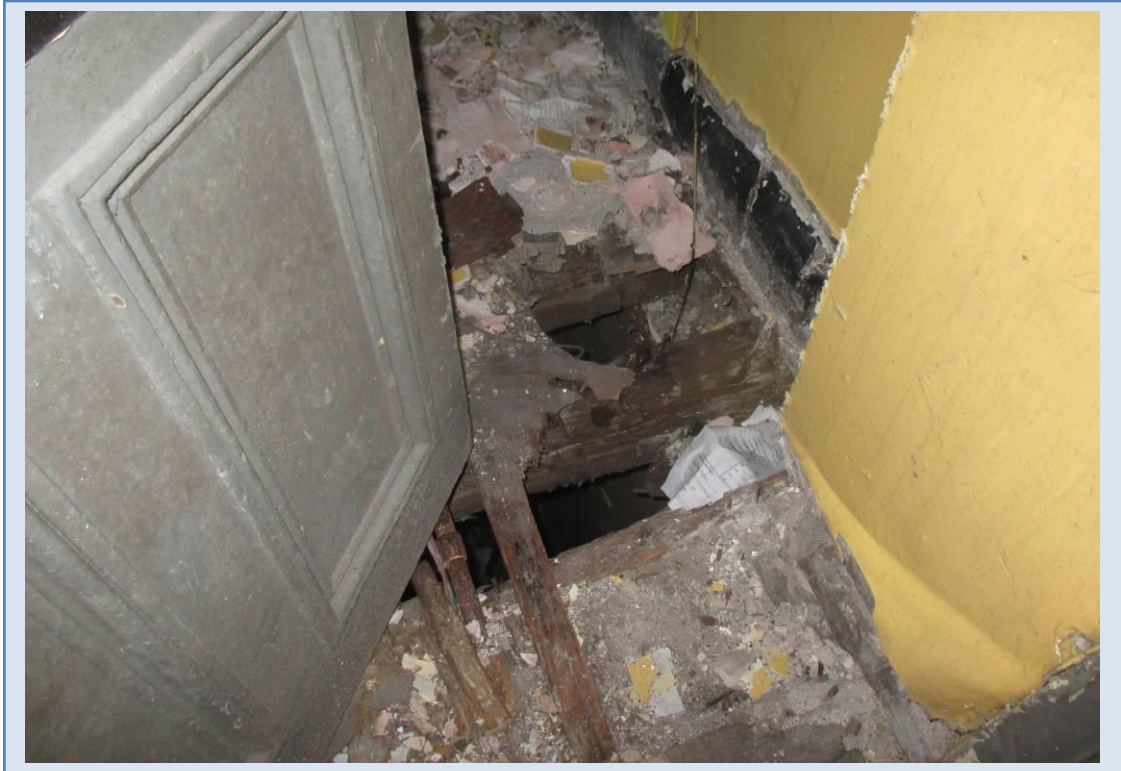
The house to the west side of building 1 was not accessible

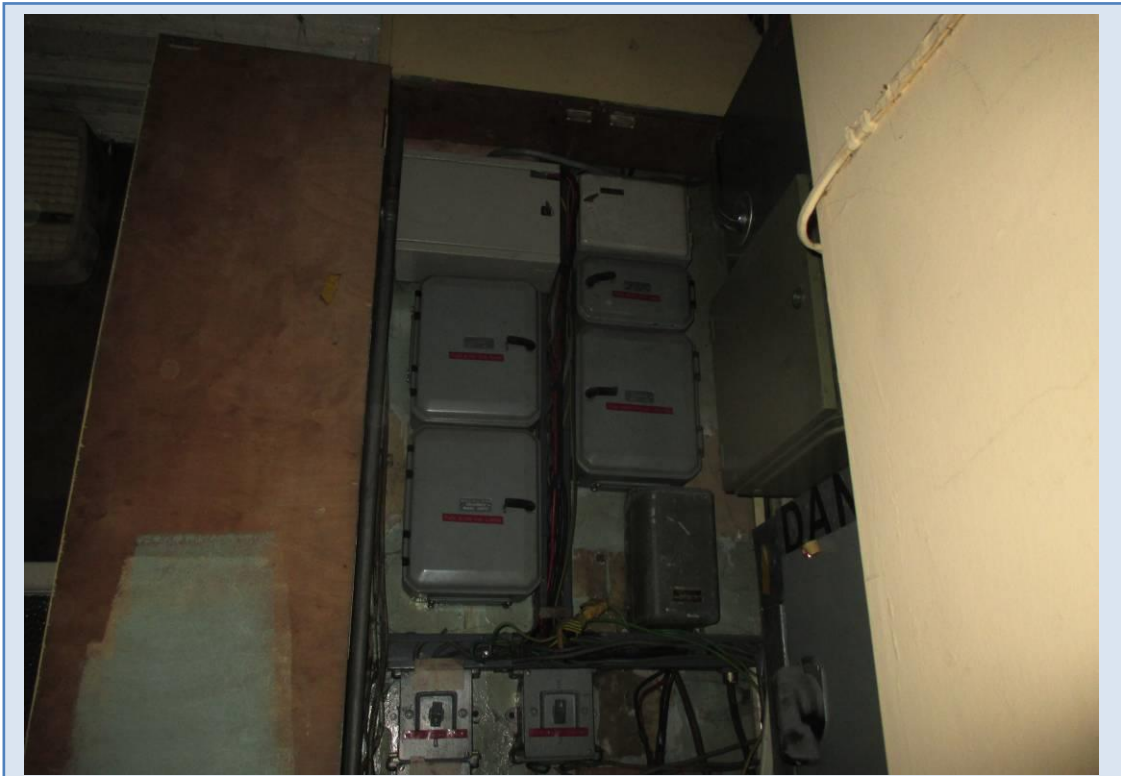
No inspection of live electrical or mechanical plant or similar requiring the attendance of a specialist engineer was carried out

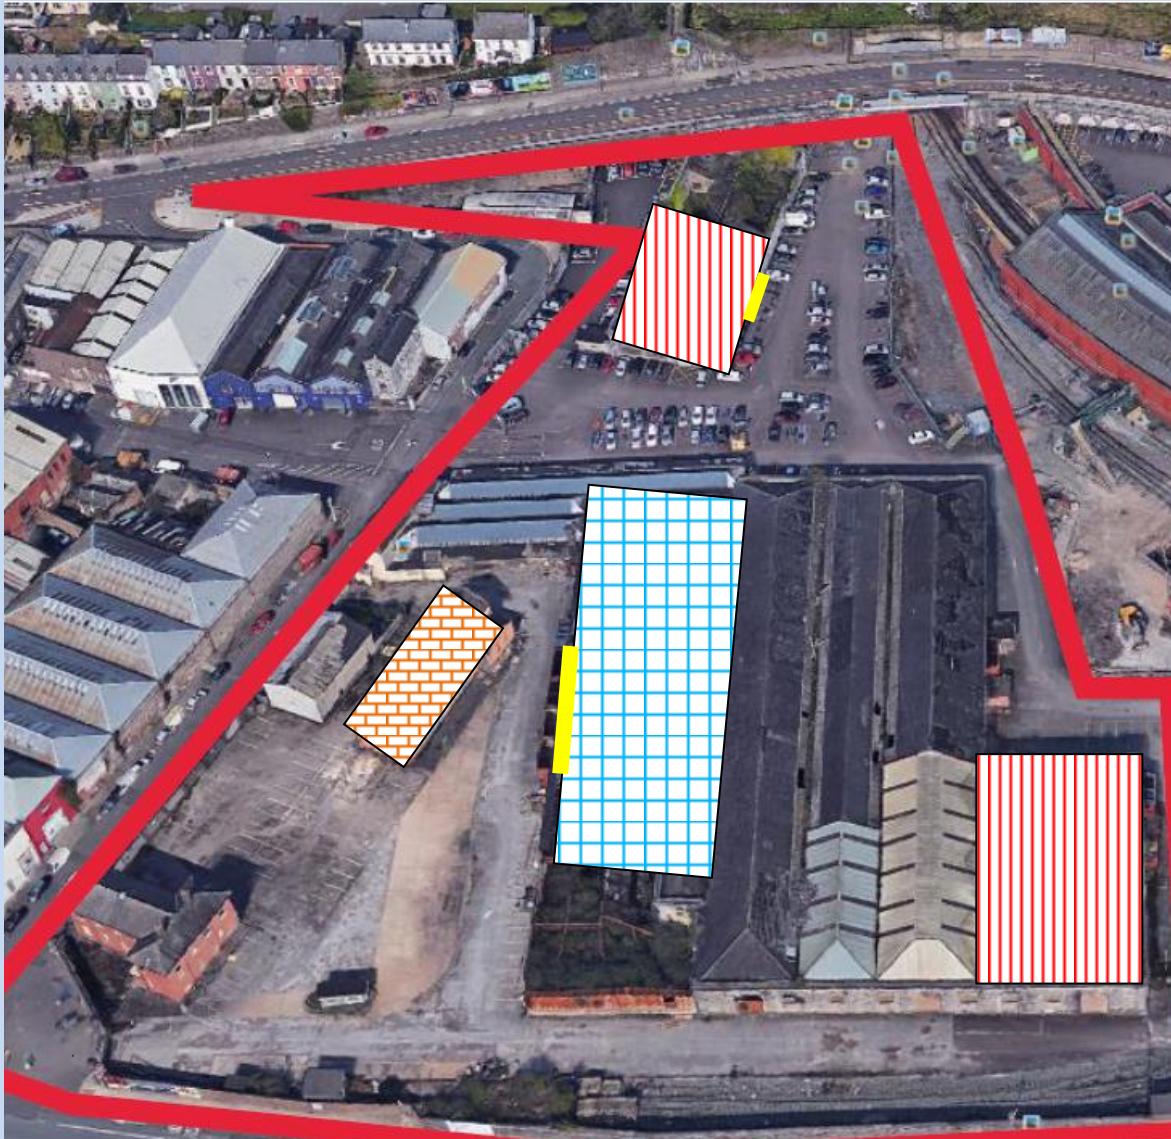
ROOF PLAN

Areas where the presence of corrugated asbestos cement sheeting & cement rain water goods were identified

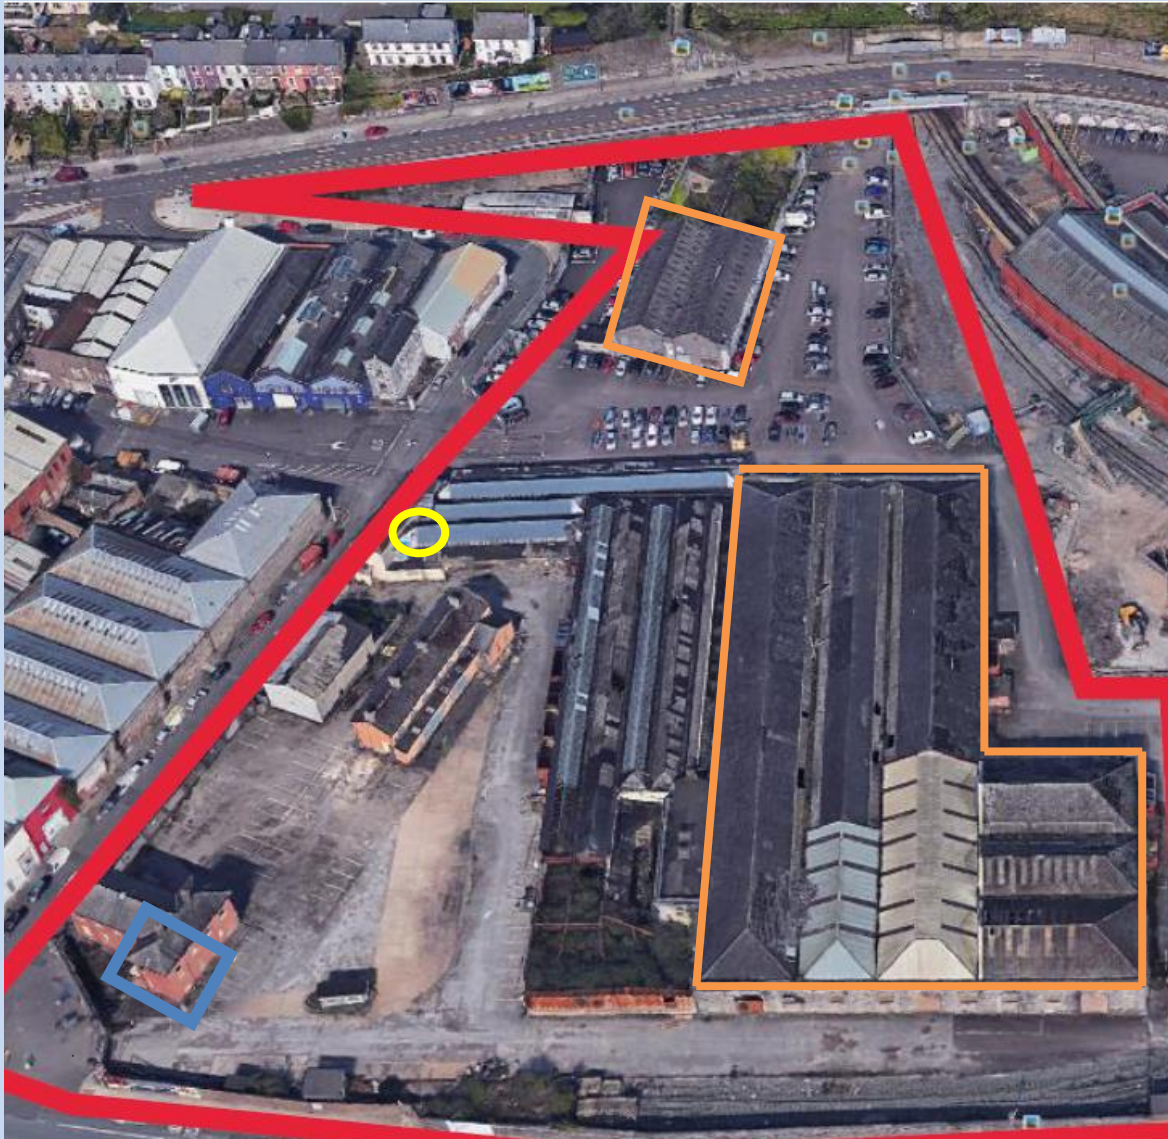
FLOOR PLAN

Areas where the presence of asbestos cement debris and CAF gaskets were identified
