## Industrial Archaeology Survey Stationmaster's Building

Fred Hamond

August 2017

## Building 2: Passenger Station

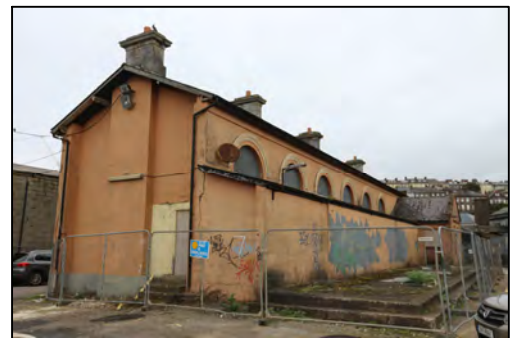
Fig.2 Passenger Station from SE.

A single-storey/ four-bay former passenger station designed by Sir John Benson and opened by the Great Southern & Western Railway in 1856 (fig.2). The building was originally much longer, with a Doric colonnade along its west side and canopied platform at east. It was superseded by a new passenger station in 1893. The colonnade and platform canopy were removed in the later 1800s and the building truncated to its present length during the 1900s.

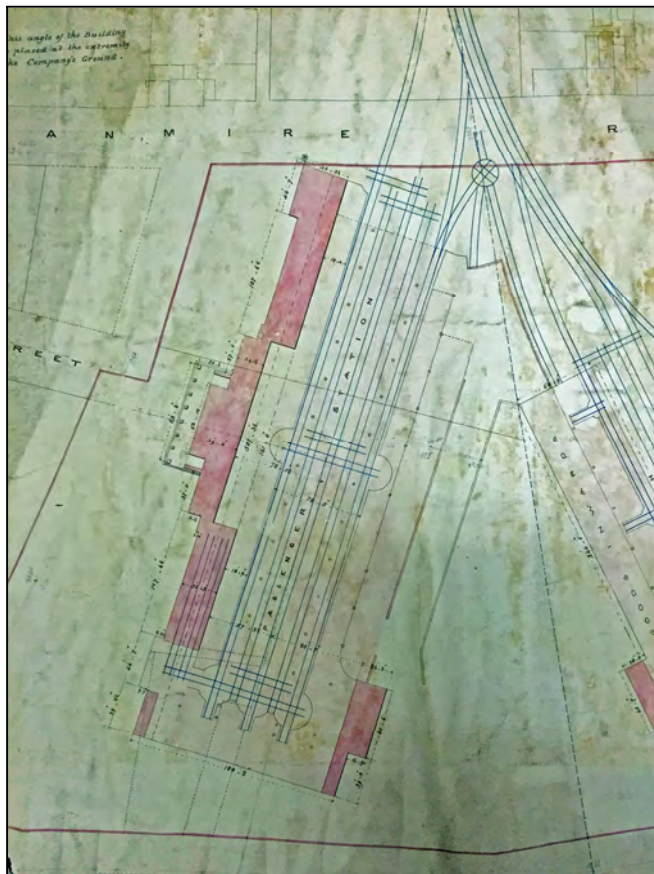
Fig.5 Dimensioned plan of station which was never built (IRRS).

Benson's design was one of several proposals for the Cork terminus. Whether it was put out to a competitive design is uncertain, but a drawing in the Irish Railway Record Society shows a proposal for an even larger passenger station tight against the NW corner of the GS&WR premises, with the colonnaded central section of its façade approximately facing the end of Railway Street (fig.5).

With an overall footprint of 507ft x 245ft, it was over four times the area of the one erected.
